Super-K status report

1/29/02 HEPAP meeting

Accident sequence

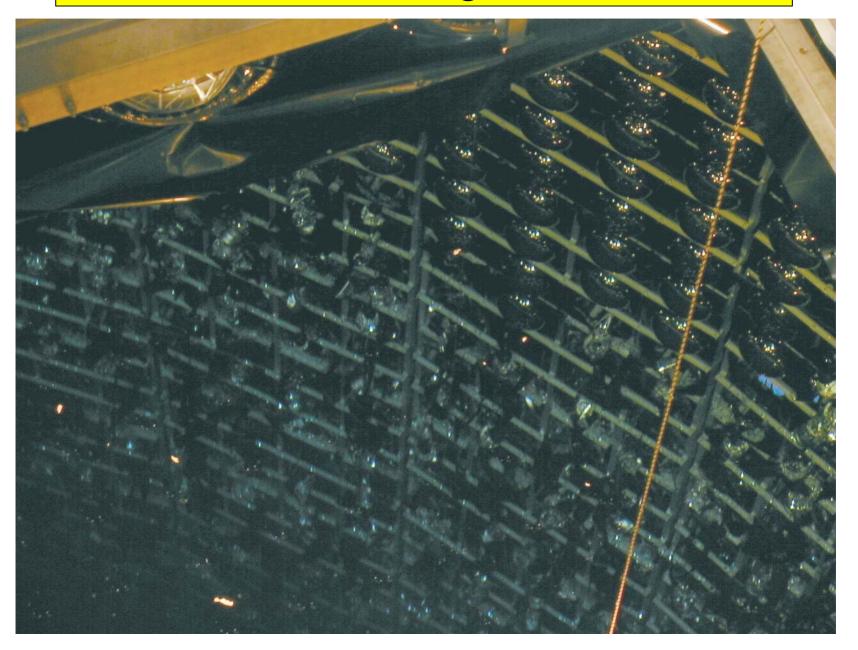
Damaged PMT's	6777 (out of 11146 20" tubes 1149 (out of 1885 8" tubes)
Electronics damage	none
High voltage damage	negligible
Wavelength shifting plates	700 (out of 1885 damaged)
Plastic, Tyvek sheeting	Needs total replacement
Cables	Still undetermined
Tube frames/housings	Extensive damage
Small water leak	4.2 tons/hr
Damage to detector structure	none

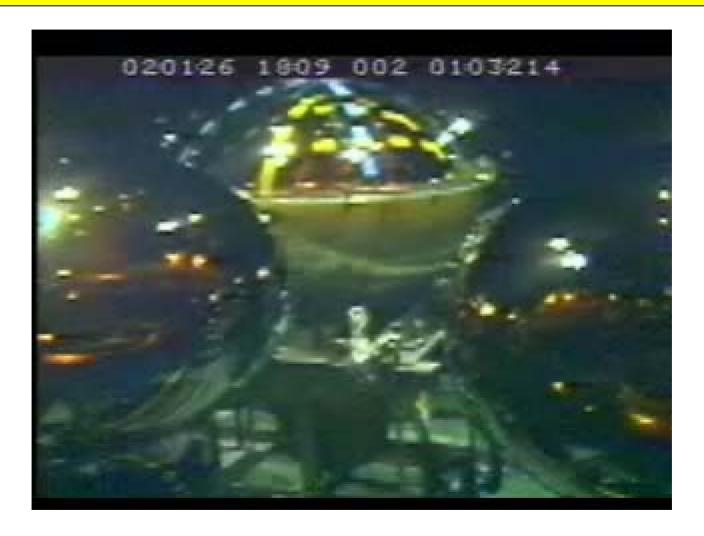
Test at 30 meters depth

10 mm acrylic, 5 mm fiberglass

- Several designs tested based on numerical simulation and experimental results.
- All include encasing each PMT.
- Perforated acrylic dome flanged to various base materials.
- Several successful designs tested at 30 meters.
- Still to be tested (this week) at 40 meters.
